*Reactivation of mass movements in Dessie graben, the example of an active landslide area in the Ethiopian Highlands*

**Landslides**

DOI 10.1007/s10346-015-0613-2

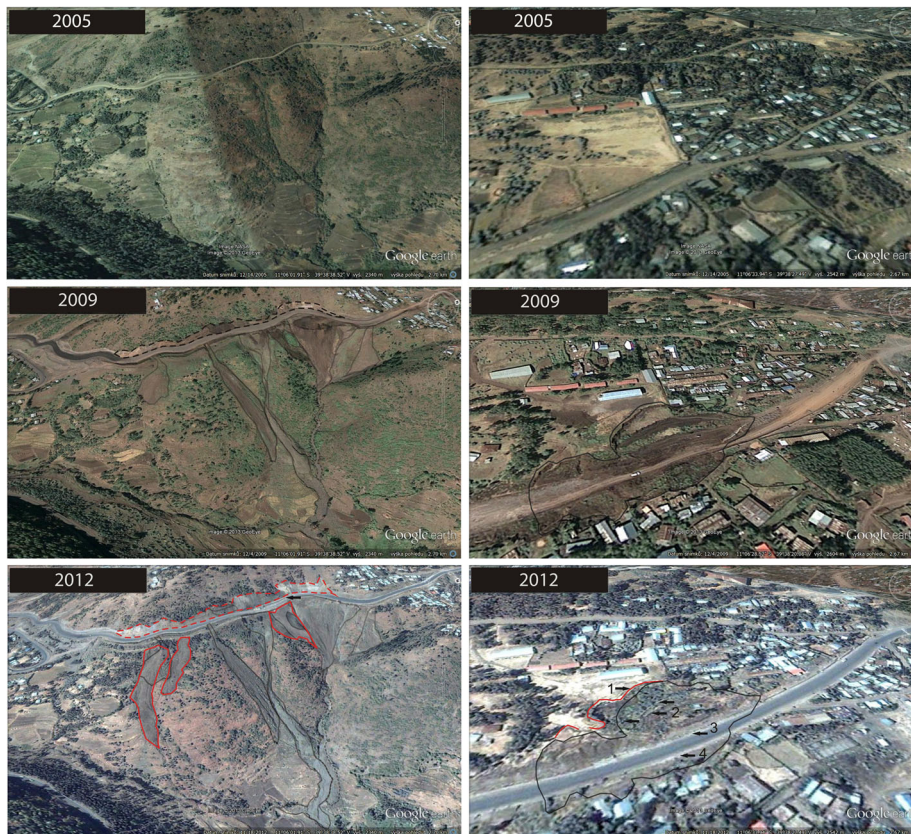
This landslide was activated during the construction of an asphalt road in 2009 (Fig. 4) and was formed on a moderate slope of 6.5° covered by alluvial sediments represented by silty clay (clayey silt) soils with an admixture of volcanic pebbles. The original landslide body was more than 110 m wide and 72 m long along the fall line from the main scarp to the road. A new school building was built just above a fresh landslide body in 2009/2010.

**Fig. 4** Comparison of the noticeable development of the studied landslide areas (Menbere Tshay area—right, Dessie–Kombolcha road—left) in the years 2005–2009–2012; the first landslide events were caused by the construction of a new asphalt road leading to Dessie town. Numbers in the Menbere Tshay area (2012) indicate the remedial works RW1, 2, 3 and 4

The geodynamic changes in the study site compared to the original state in 2005 and the situation in 2009 and 2012 are clearly visible on Fig. 4. The biggest problem in this zone is the traffic on the asphalt road, which is threatened by rock falls or rock slides from the steep cliff edges. For this reason, retaining structures (concrete grids and gabions) and retaining walls above the road have been built and other technical measures are still under construction.

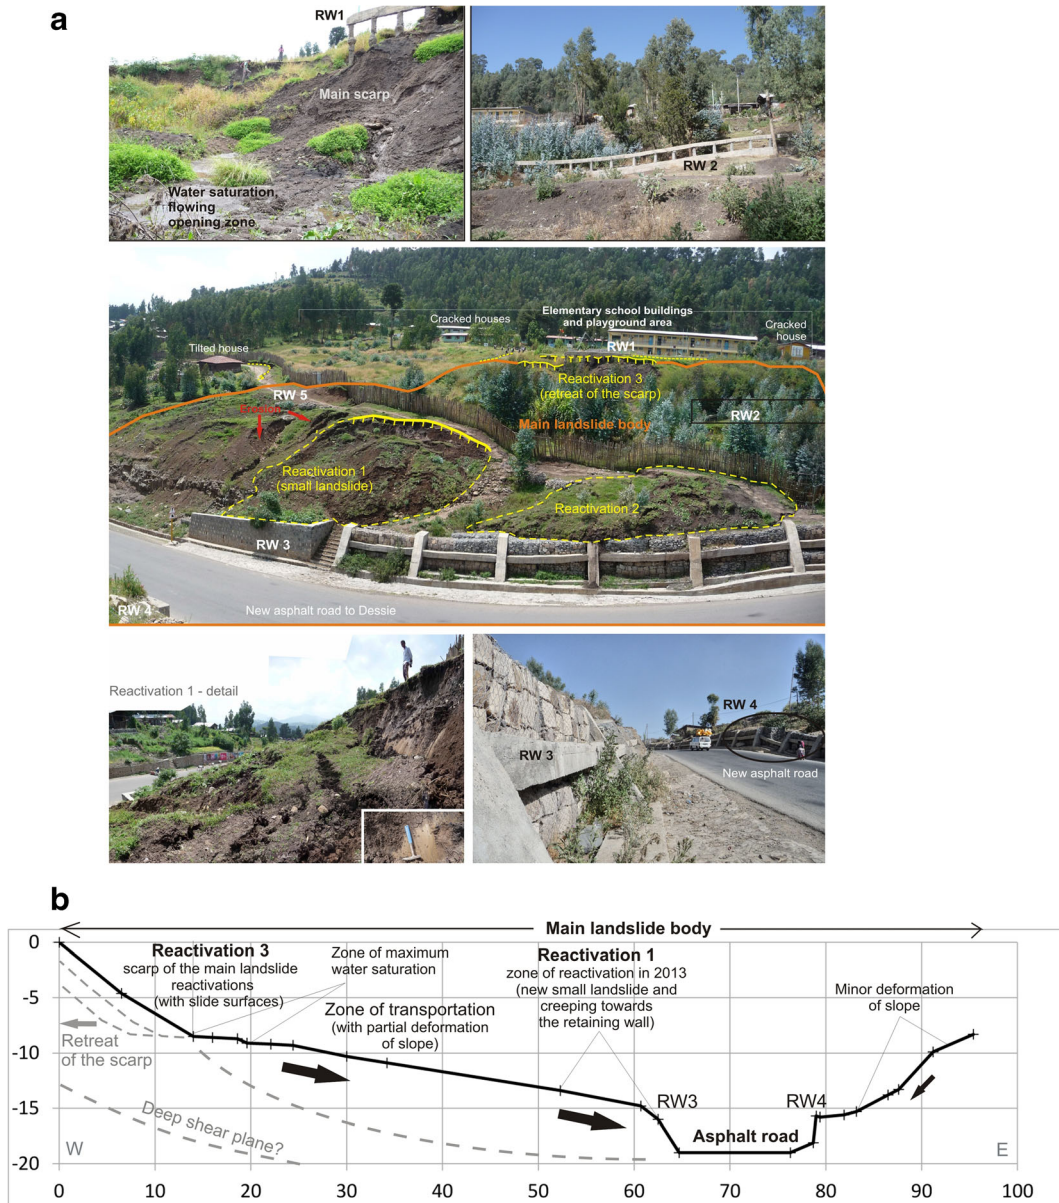
The first reactivation after intensive rainfall was described in 2010 (Beyene et al. 2012). Several technical measures were applied within the landslide area in 2010—a retaining wall along the road (see the remedial works/RW3, 4 in Fig. 5a), a stabilizing wall with piles along the main scarp and transverse cracks (RW1 and RW2 in Fig. 5a) and plantation of eucalyptus trees. The pedestrian path along the southern part of the school grounds was partly stabilized by gabion as an erosion control measure (RW5 on Fig. 5a).

Despite this remedial work, slow sliding of soil material was observed by local people every year within the source area of the landslide, especially during the rainy season. Fresh reactivations of slope sediments were also documented after the rainy season in October 2013: (i) a new small landslide body next to the road (55 m wide, 16 m long along the fall line, a scarp with a height of 1.6 m and with partial tears around—see Reactivation 1 on Fig. 5a, b); (ii) another part of the soil material was moved and pushed to the abutment walls along the road (Reactivation 2 on Fig. 5a); (iii) partial landslides after several sliding surfaces along the main scarp zone (Reactivation 3 on Fig. 5a). The analysis of high-resolution satellite images revealed that the main scarp advanced 12 m towards the school buildings and reached the retaining wall (see the close-up photo of RW1 on Fig. 5a). This advancement reached 18 m in the unprotected terrain to the south of the wall. The landslide area limited by the scarp and by the asphalt road is 7800 m<sup>2</sup> which is 17 % larger than in 2009.

Open cracks in the surface parallel with the southern edge of the landslide extend to the slope in a direction towards the school buildings (with a length of 8 m, depth of 0.3 to 1.10 m, becoming deeper and wider in the lower parts of the slope). Open cracks on the school playground parallel to the scarp edge of the landslide are 6 m from the retaining wall and were filled with gravel. Relatively fresh cracks measuring

**Fig. 5** a Overall view of the landslide body near the elementary school in the Menbere Tshay area (photo Z. Vařilová). b Longitudinal topographic profile of the landslide

There are many indications that this old landslide body is still active and hazardous. Moreover, the irregular tension cracks and shears in school buildings and a tilted house on the south end of the school grounds (Fig. 5a) show that the unstable area is wider than the original landslide from 2009. The ridge further above the school grounds is built of solid volcanic rock and represents the upper limit of the whole

The whole area of the school grounds between the new asphalt road and the upper path is threatened by landslide reactivation. In addition, it is clear that progradation of the main scarp edge will continue towards the school building during the next rainy period. The hazard level is high due to the threat to the school building and school facilities above the source zone and the road in the accumulation zone. School staff confirmed that the school administration requested assistance from the government to solve the arising problems.

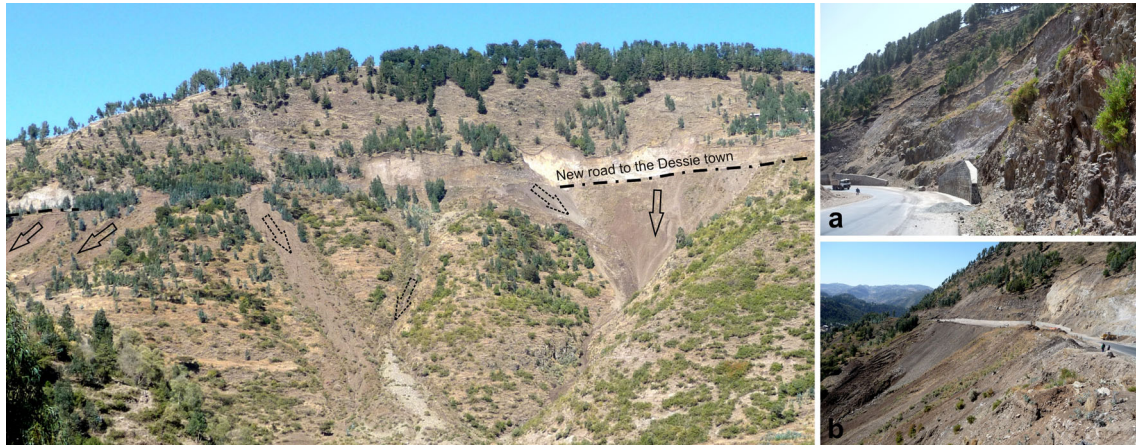
This hazard area extends more than 1 km along the road and has two main features: (i) highly damaging rock falling from the steep slope (60–80°) and rock walls above the road together with (ii) six well-marked debris flows with their source area below the

level of the road (Fig. 6). The material of the debris flows is a combination of natural colluvial deposits, soils and artificial land-fill. Newly opened lateral cracks and a down-dip block (1–2 m wide) behind the scarp (currently about 20–30 m from road) were observed. Movement of the unconsolidated material and the creation of the deep erosion gullies partly correlate with the man-made drains under the road.

The hazard level in this locality is now moderately low compared to the other described sites; thanks to the implementation of remedial measures and the fact that there are no settlements in the area below the slopes. From a long-term perspective, the gradual erosion and cutting processes on the top edge of several debris flows towards the asphalt road may cause problems.

**Fig. 6** Several debris flows below the cut of the new road from Kombolcha to Dessie; close-up photos **a** scarp in stratified volcanic rocks over the road (along with the construction of the massive retaining walls) and **b** the upper part of the largest debris flow (photo Z. Vařilová)

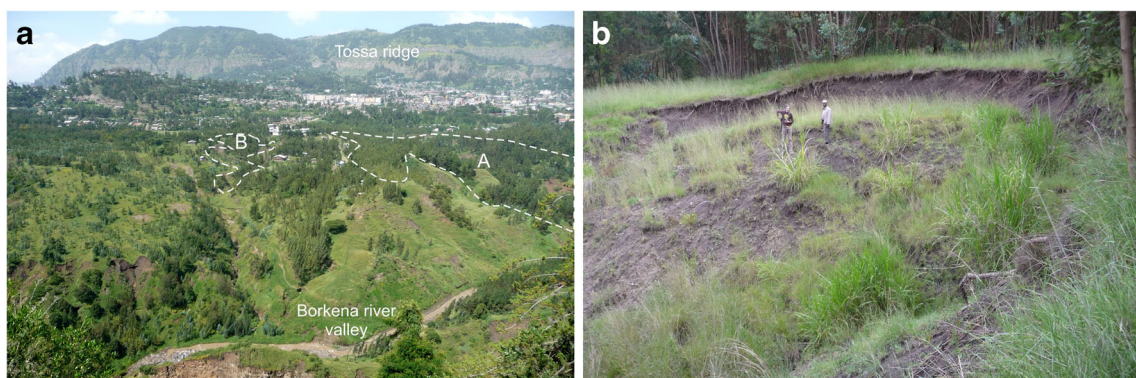
Various types of recent minor landslides (slump translational planner), longitudinal and transverse cracks were identified in this area. The slope failures of the unconsolidated material are induced by undercutting by the Borkena River and its tributary. This site can be divided into two parts denoted as A and B in Fig. 7.

Northern landslide, part A: This zone is represented by an old landslide along the bed of the tributary of the Borkena River. It was reactivated 6, 2 and 1 year ago (based on oral information from the local inhabitants). Another reactivation was observed in the southern part within a large old landslide above the Borkena River. This reactivation is approximately 3 years old. Deep erosional gullies

Southern landslide, part B: This landslide is located on a slope with an inclination of 17° at the end of a small E-W orientated valley. The landslide crown is retrogressing up the slope. Nowadays, it is directly bordering a new housing area. Construction of the housing began in 2005 and the built-up area covers a total of 67 ha (Fig. 8). The upper edge of the receding slope represents a threat to the houses. The last large event occurred 3 years ago. New deep cracks at a distance of 5 to 10 m from the houses were observed in 2013. Erosion and recurrent slope movements are induced in connection with intensive rainfall. Every year, a number of new small landslides are registered.

**Fig. 7** **a** Two main landslide zones within the Kerra area (A, B) and **b** one example of a recently developed minor landslide observed there in 2013. Other shallow landslides and abundant creeping are clearly visible between the landslides A, B and the Borkena river valley (photo Z. Vařilová)

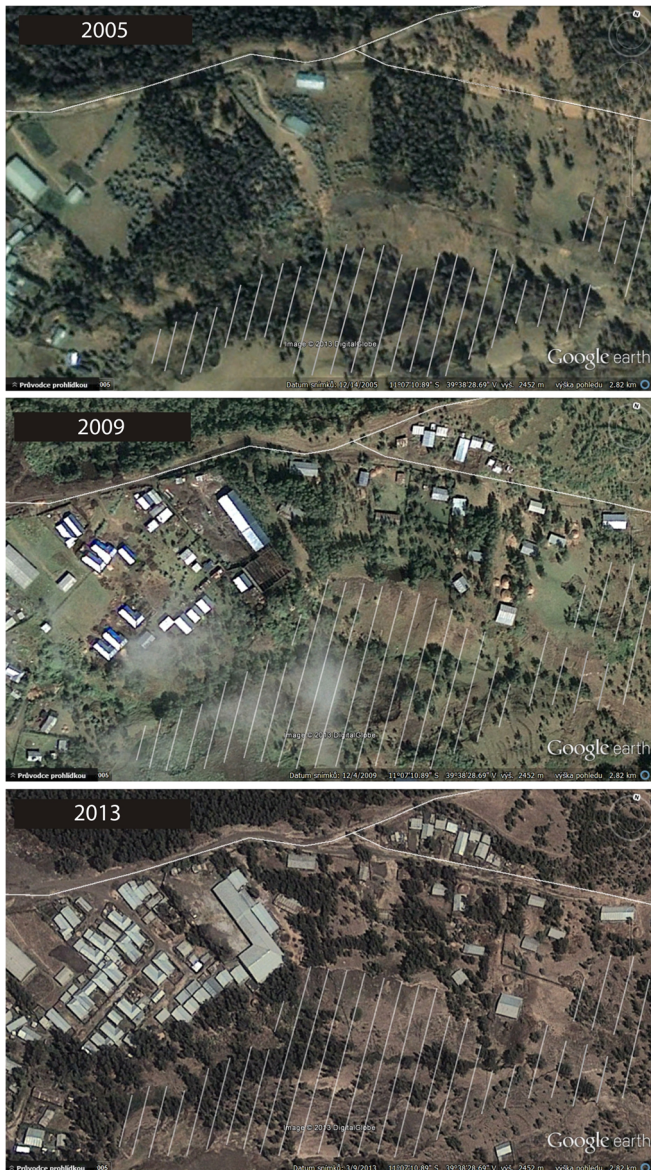
**Fig. 8** Satellite images showing the local deforestation and the rapid expansion of settlements in the vicinity of the landslide area (Kerra B—indicated by *hatching*). The built-up area has grown by nearly 6700 square metres in a period of 8 years in this area. This is a typical example of a natural hazard area which will become risky due to changes in land use

phenomenon is observed here, namely the building of new houses near the unstable slope which is directly threatened by landslide activity. There is a clear lack of urban planning that would take into account the potential risks as well as an operational control system that would prevent the building of houses in potentially affected areas. The houses are only a few years old, and eviction from the risk zone is currently under discussion. Interviews with the local inhabitants revealed that they had been relocated to this area from another endangered site.

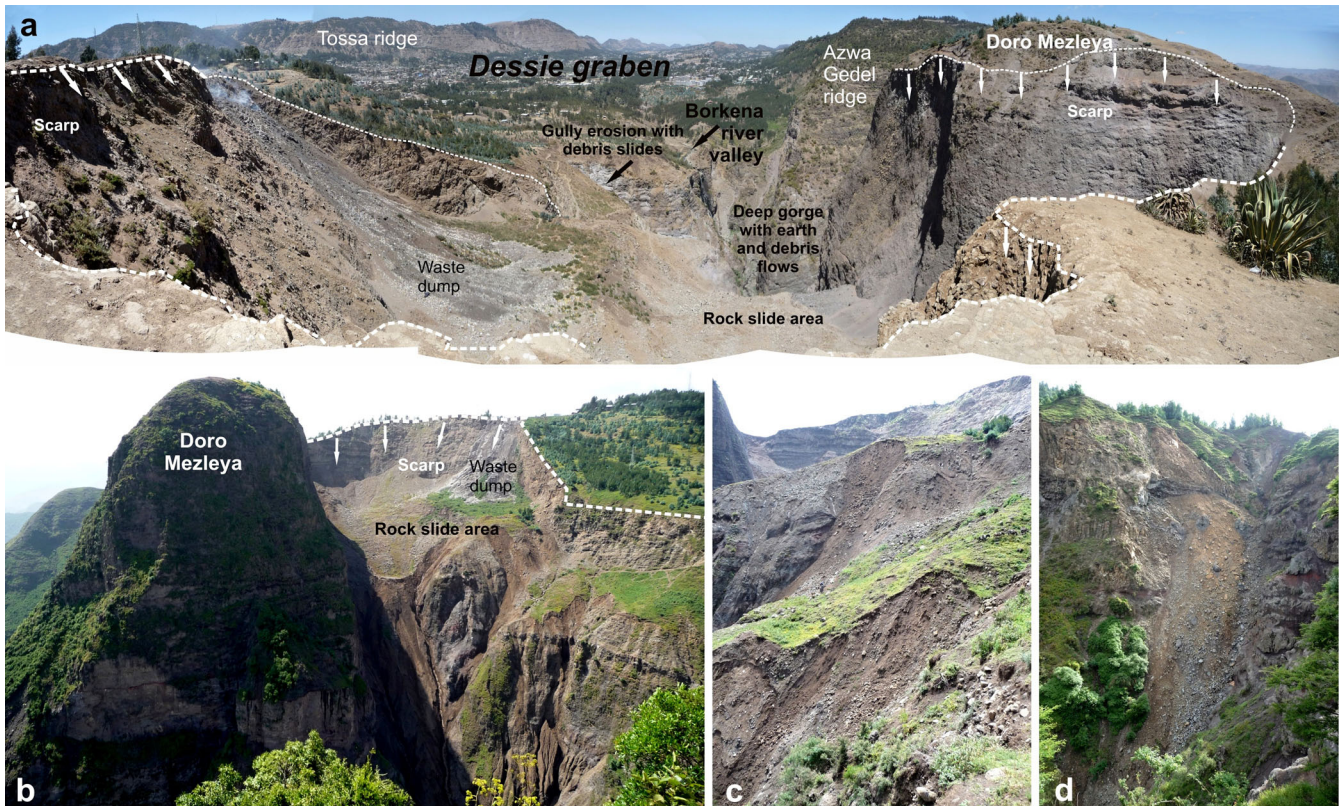
Mezleya. The scarp of this huge rock slide/avalanche is directly visible from the city centre (Fig. 9). The tectonic setting (and rock structure) together with the very steep topography and local drainage system predispose the landslide and play a key role in triggering the hazard in this locality. It is located at the outlet of the Borkena River from the basin which forms a narrow 300-m-deep gorge following the fault. The topography of this site is extremely steep due to the backward erosion of the Borkena River, which is marked by a waterfall some 200 m up-stream from the accumulation zone. The Doro Mezleya rock massif is built up of stratified and highly weathered basalt. The site coincides with a crossing of two fault zones (see Fig. 2).

The Borkena River is gradually eroding the base of the sliding mass and adjacent slopes destabilizing blocks in the upper part of the gorge. The main landslide body is currently about 260 m wide and 450 m long. The landslide spans an elevation range of 320 m while the head scarp is 25 m high. The source area has an inclination of  $42^\circ$  while the lower part of the slide is much steeper ( $50^\circ$ ). The eastern part of the subvertical fault scarp follows a N-S direction towards the Azwa Gedel ridge fault. The western side is characterized by a gently inclined slope with a sharp edge several metres high (see Fig. 9a). This upper edge is formed by columnar jointing of volcanic rocks with an inclination of  $48^\circ$ . The northern part of the block of Doro Mezleya hill is separated by a fissure and shows a subvertical displacement in the order of 6 to 7 m (documented by stratigraphic comparison of adjacent blocks and measured using the laser rangefinder).

Occasional rock falling and small block slides into the gorge are common events. Recent local reactivation (local rock falls and debris flows) could be also influenced by small scale quarrying activities by local people, which take place in the middle part of the rock slide area (Fig. 9c). The upper western part of the scarp is used as a waste disposal site for the town, and the landfill accumulation is gradually increasing in volume and areal extent.

**Fig. 9** Doro Mezleya landslide area: a view from the upper southern edge of the scarp towards the Dessie graben with the Borkena river valley, b view of the whole landslide area from the Azwa Gedel ridge pathway, c small reactivation in the central part of the landslide area partially influenced by quarrying activities, d rock fall in the erosion gully adjoining with landslide area to the north (photo Z. Vařilová)

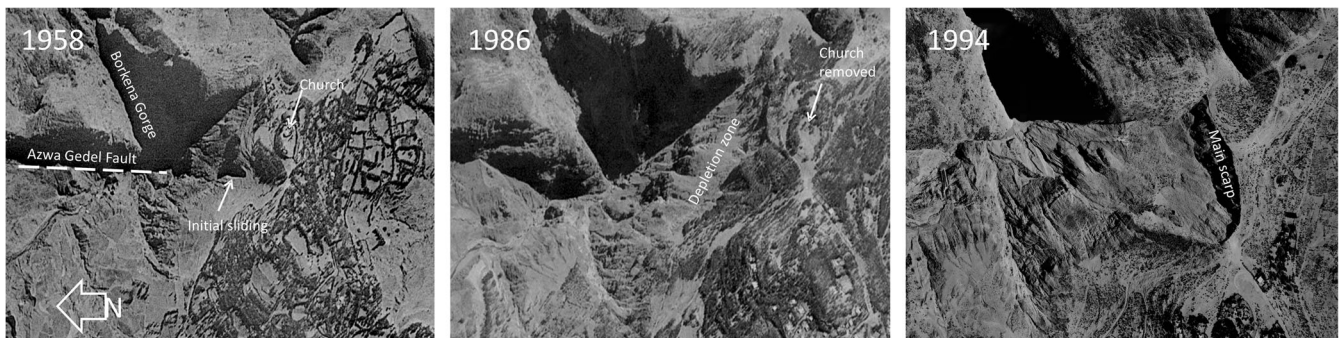
This huge landslide is mentioned several times in the literature (Ayenew and Barbieri 2005; Suyum 2011; Eshetu et al. 2013). Unfortunately, information on the precise timing of the landslide event and its reactivations is missing. Subsets of aerial photos provided by the Ethiopian Mapping Agency show that the sliding occurred in several phases. Erosion and an initial sliding are already visible on the photograph from 1958. This was followed by a mass movement affecting the whole width of the valley. During this significant phase of the landslide activity (rapid slope failure/rock avalanche), a massive part of the slope collapsed damaging an electrical tower, property of local residents, and a church situated on the slope (Eshetu et al. 2013, oral information). The triggering factor of this slope failure was likely an earthquake in the 1970s (oral information from the local people). Earthquakes with their epicentre 33 and 35 km from Dessie were recorded in 1977 and 1979, respectively (Gouin 1979; USGS). However, the largest changes in landslide morphology were newly identified from aerial photographs between 1986 and 1994. These changes could be possibly linked to earthquakes in 1990 or 1993 with their epicentre about 10 km from Dessie (USGS). Based on the observed data and new information, it is clear that the sliding activity occurred in several phases (Fig. 10).

**Fig. 10** Subsets of aerial photos of the Doro Mezleya locality provided by the Ethiopian Mapping Agency showing that the sliding occurred there in several phases. The major sliding took place between 1986 and 1994
