*The reconstruction of a glacial lake
outburst flood using HEC-RAS and its
significance for future hazard assessments:
an example from Lake 513 in the Cordillera
Blanca, Peru*

Nat Hazards (2014) 71:1617-1638
DOI 10.1007/s11069-013-0968-4

The reconstruction of a glacial lake outburst flood using HEC-RAS and its significance for future hazard assessments: an example from Lake 513 in the Cordillera Blanca, Peru

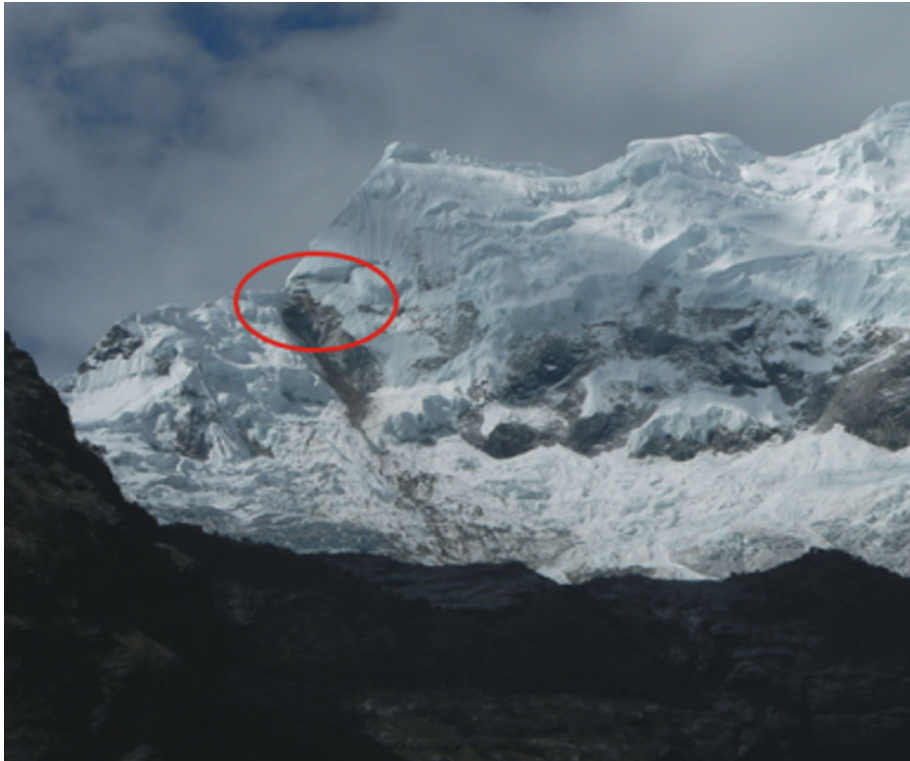
Fig. 4 The source area of the ice/rockfall that occurred on the south-western facing wall of the mountain of Hualcán in April 2010 (indicated by *red circle*)

detachment area was located at around 5,200 m asl (Fig. 4), and its estimated volume was between 300,000 and 1,000,000 m³ (Schneider et al. 2012) or 200,000–400,000 m³ (Carey et al. 2012). It moved across steep glaciers and down a 190-m high cliff into Lake 513, whose constant water level is maintained by the outflow at 4,431 m asl. The displacement wave is thought to have attained a total height of around 24 m and overtopped the bedrock dam by around 5 m. It partly eroded the overlying moraine dam and continued in a bedrock stream channel until it entered a steep deep channel incised by up to 15 m into the glacial and colluvial sediments below Rajupaquinan Lake ('B' in Fig. 5). From this point, intensive erosion and material entrainment continued for about 1 km until energy loss led to deposition as the steep stream gradient shallowed to the broadly horizontal surface of the Pampa Shonquil ('C' in Fig. 5). It has been determined that between 50,000 and 80,000 m³ of mainly coarse sediment (11.8 in Figs. 2, 5) was deposited over an area of about 100,000 m². Further downstream, although still within the palaeo-lake basin, the river eroded into the sediments during the highest water discharge. Thereafter, the stream slowed and accumulation was dominant. The accumulated material was comparatively fine-grained (10 in Figs. 3, 6) with more than 23 % of the particles finer than 10 mm and 50 % finer than 80 mm. This contrasts with the accumulated material at the onset of the palaeo-lake basin in which only 19 % of the particles were finer than 100 mm and 50 % were greater than 270 mm—this was the coarsest sediment sampled during the fieldwork (11.8 in Fig. 6).

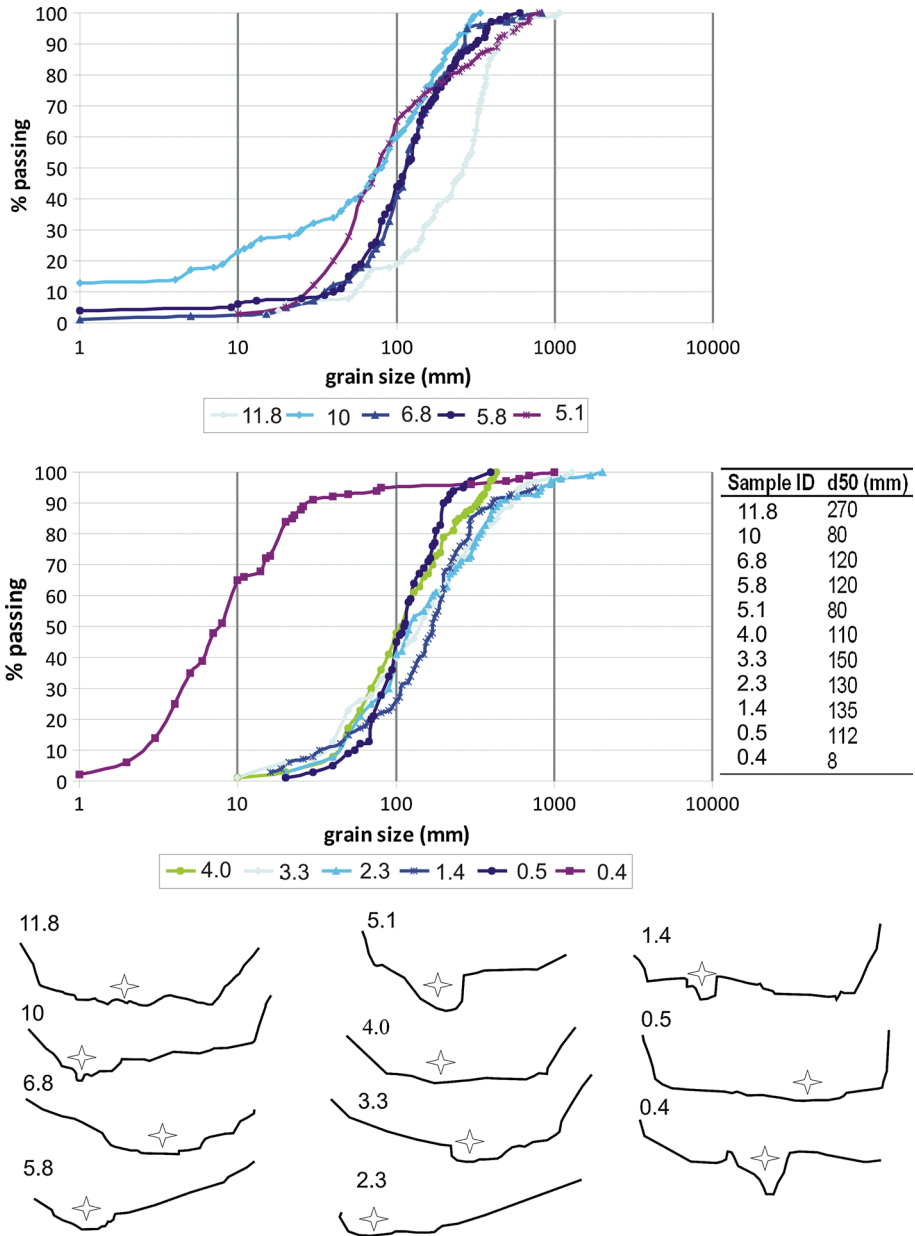
Fig. 6 The granulometric curves obtained from the flood sediments using the method of Wolman. The table shows the diameter of the particles that comprise 50 % of the sample (the samples are named according to the river station—for locations, see Fig. 3), while the lower part of the figure shows the sample location within each cross-profile (indicated by asterisks)

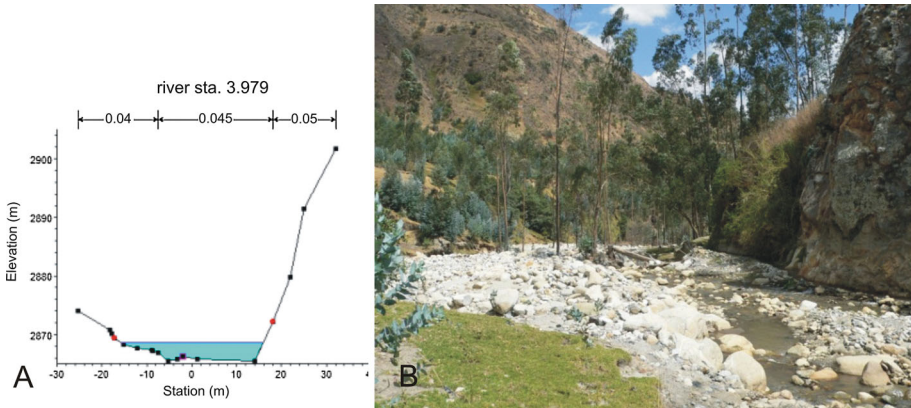
Fig. 7 An example cross-section from Station 3.797 with Manning's n values (numbers at the top of a) together with a field photograph of the site: the view downstream corresponds to the orientation of the cross-section

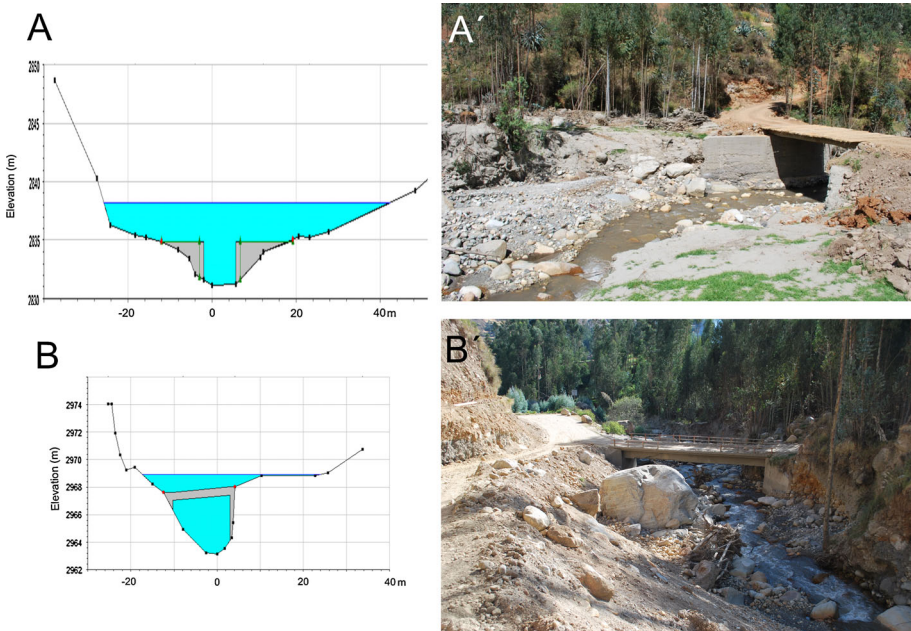
Fig. 8 A, A' The water surface elevation during peak flow at the cross-section where the bridge was destroyed along with a photograph of the site; B, B' the water surface elevation during peak flow at the cross-section adjacent to the bridge to the Hualcán Village which survived with only aesthetic damage (the bridge foundations are shown in light grey)

The HEC-RAS software calculates the water surface elevation during the peak discharge of the flood at each of the cross-sections used for the model. Figure 8 shows the level of the flood at the site where the bridge crossing the river was destroyed (Station 3.292 km) and the level of the flood at the bridge to Hualcán Village (Station 5.061 km), which survived with only aesthetic damage. The modelling results suggest that the destroyed bridge was about 3 m below the water level during the flood event, while the bridge to Hualcán Village was only 1.2 m below it. The extent of the water surface during peak flow at each cross-section was then used to define flooding lines along the whole length of the stream (Fig. 9), which were adjusted to the actual topography. This allows the total flooded area to be estimated as $700,000 \text{ m}^2$. In most parts of the basin, the flood was confined to the river channel, but in some parts of the alluvial fan at Carhuaz, it extended up to 70 m onto the floodplain on each side of the river (Fig. 9; Table 1).

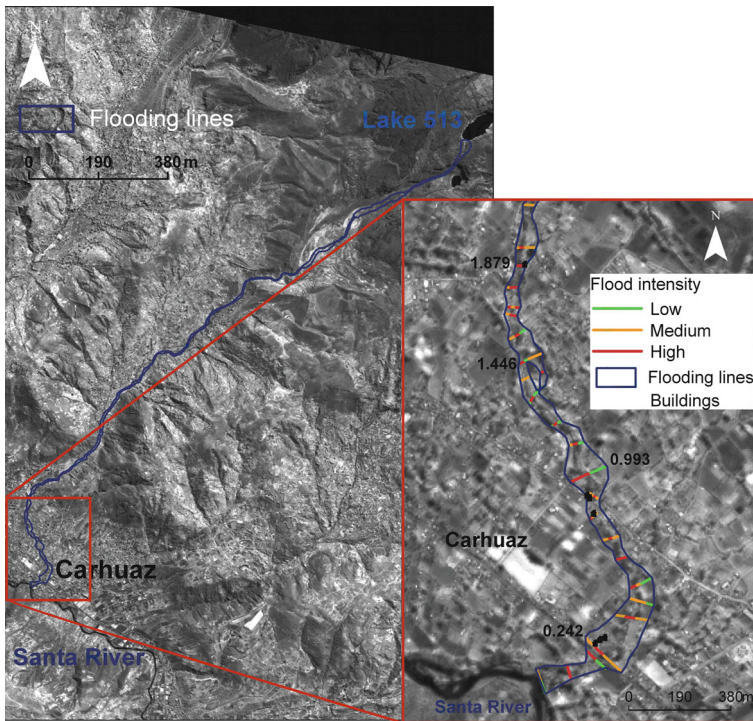
Fig. 9 The water surface extents were used to delimit flooding along the stream (*blue line*), while the calculated water depths were used to define the intensity of the GLOF at each cross-profile; intensity classes are shown for the lowest river reach on the alluvial fan in Carhuaz (*inset of the figure*)

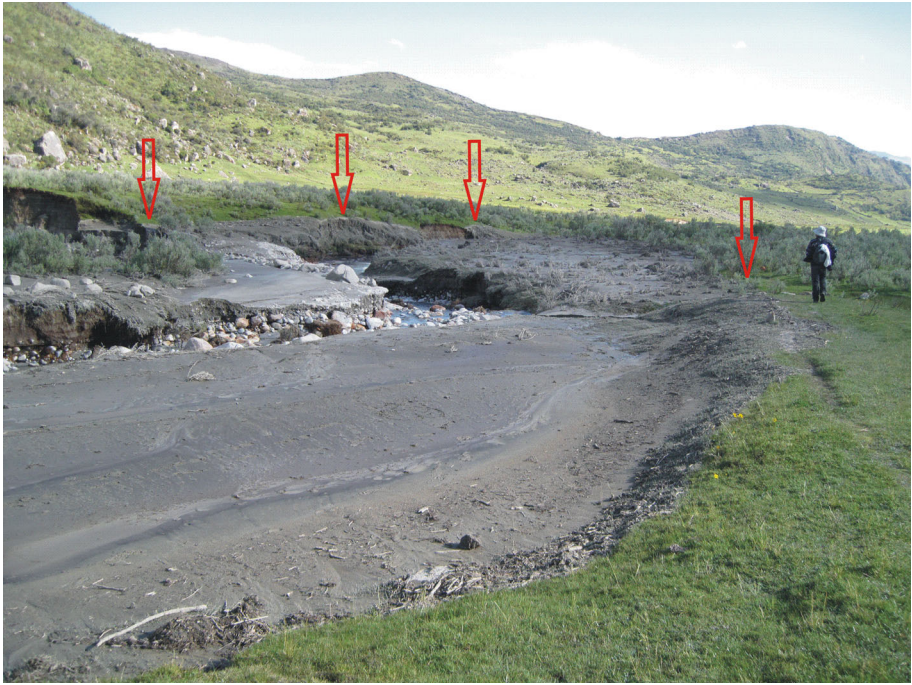
Fig. 10 The flood extent as evidenced by a photograph taken within few hours of the event during the first field investigation conducted by experts from ANA-UGRH in Huaraz

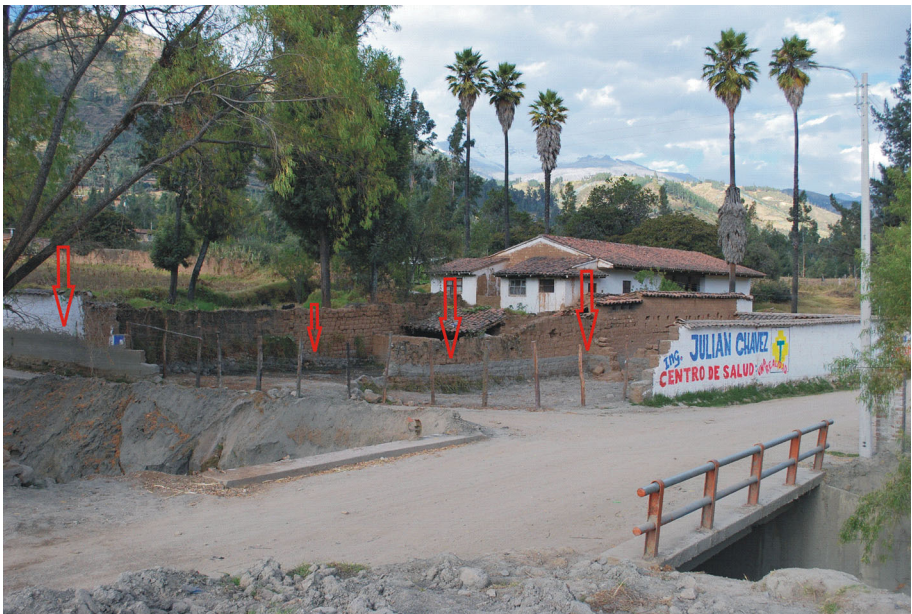
Fig. 11 The flood mark on Station 0.885 km is indicated by grey mud on the partly destroyed adobe wall. The photograph was taken by the authors during fieldwork in 2010

In addition, there is good agreement between the computed travel time needed for the displacement wave to reach Carhuaz and that of eyewitness accounts recorded during fieldwork in 2010. The extent of the flood mapped by the HEC-RAS model was verified through comparison with field photographs taken shortly after the event (Fig. 10) as well as with the field notes of the experienced scientists who conducted fieldwork immediately after the event. The flood extent, as defined by fine-grained sediments overlying the pre-flood surface, was mapped in 25 cross-sections spaced along the length of the stream. In only four cases, the calculated water level was below the mapped position, but this model error was never larger than 1 m, and in most cases, the discrepancy was only 0.5 m. Therefore, there are no notable discrepancies between the model and the field observations. In addition, the flood marks found in the lowermost stream reach also accord with the modelled water surface elevations (Fig. 11).
