Dam breach reconstruction of the Blažňov pond caused by extreme hydrological event

Abstract

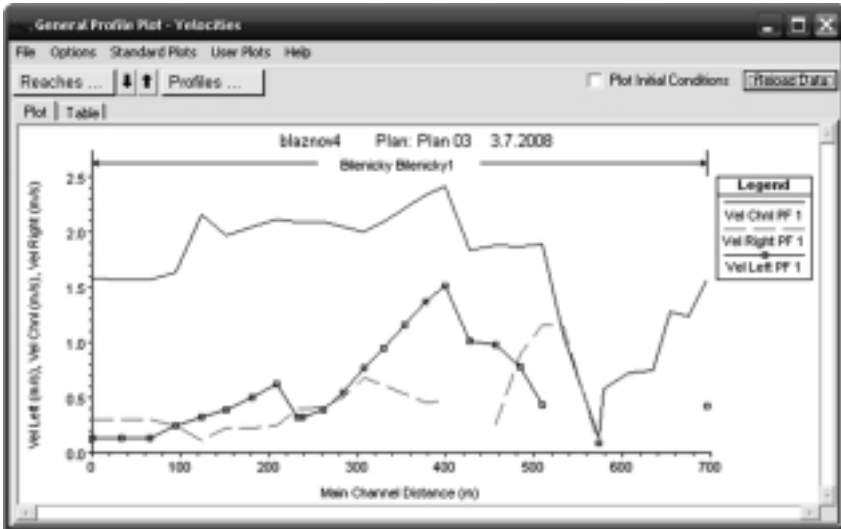
Fig. 7: Change of velocity throughout the whole reach. The line without markers represents channel velocity, line with square marker represents velocities in the inundation bank and dashed line represents velocities in the right inundation

The velocity distribution through the reach is presented in the Figure 7. The lines represent the velocities in all nodes of the river network (cross-sections) for the channel, the right and the left bank. Rapid decrease at channel distance 572 m indicates a presence of the pond, in this time almost empty.

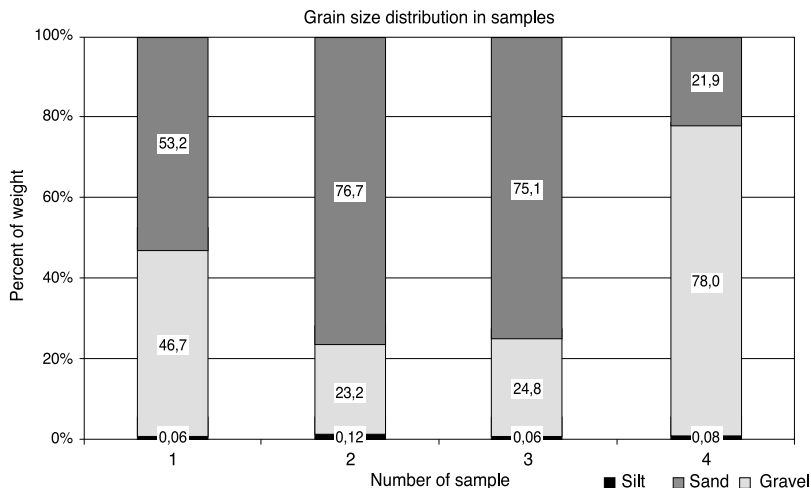
Fig. 8: Grain size distribution in samples

The flow velocity as well as the grain size of transported and deposited materials depends on the flood phase and on the river reach. Gravel is transported simultaneously with the sand. When the flow velocity decreases, the gravel sediments and the sand is transported until additional velocity decreasing (Růžičková et al., 2003). This was proved also by obtained sediment samples, where the probe no. 4 (obtained within the largest distance from the broken dam) displays three times higher abundance of sand fraction compared to probes nos. 1, 2 and 3 (see Fig. 8).

In all probes the ratio of gravel and sand fractions coincidentally outweighs over the fine-grain material of the grain size under 0.05 mm (Tab. 2). The probes no. 1 and no. 3 are the most similar regarding the grain compositions. The coarsest sample is the probe no. 2 (fine gravel, grain size approx. 5 mm). Grain size distribution of samples 1 and 3 corresponds to sand and gravel and sample 4 contains particles from 1 to 2 mm (sand).
