*Reactivation of mass movements in Dessie graben, the example of an active landslide area in the Ethiopian Highlands*

**Landslides**

DOI 10.1007/s10346-015-0613-2

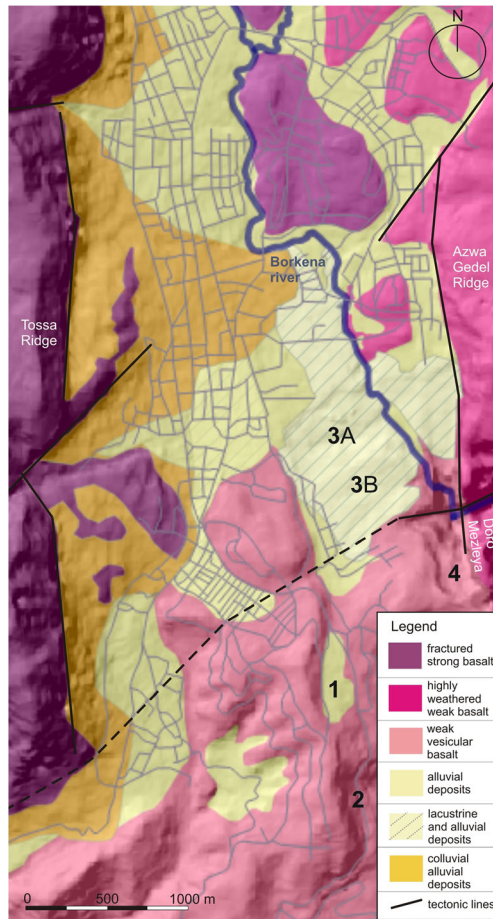
**Fig. 2** Geological map of the central and southern part of Dessie town showing the four studied areas with landslide reactivations: 1 School\_Menbere Tshay area, 2 Dessie-Kombolcha road, 3AB Kerra area, 4 Doro Mezleya landslide (modified by Ayenew and Barbieri 2005 and by Fubelli et al. 2008)

Mezleya. The scarp of this huge rock slide/avalanche is directly visible from the city centre (Fig. 9). The tectonic setting (and rock structure) together with the very steep topography and local drainage system predispose the landslide and play a key role in triggering the hazard in this locality. It is located at the outlet of the Borkena River from the basin which forms a narrow 300-m-deep gorge following the fault. The topography of this site is extremely steep due to the backward erosion of the Borkena River, which is marked by a waterfall some 200 m up-stream from the accumulation zone. The Doro Mezleya rock massif is built up of stratified and highly weathered basalt. The site coincides with a crossing of two fault zones (see Fig. 2).

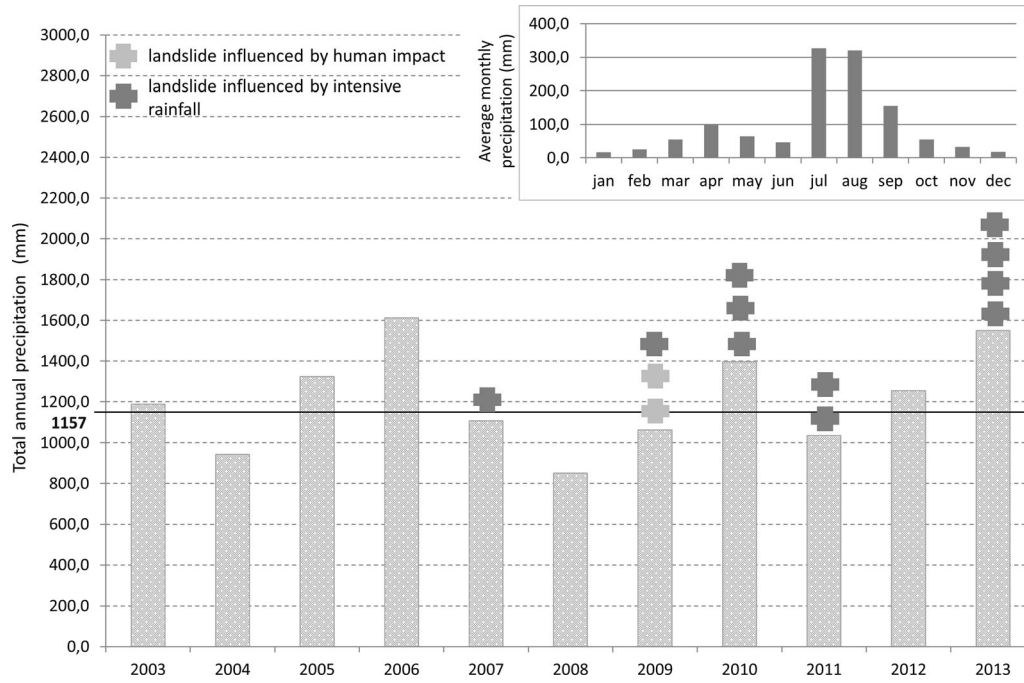
The long-term meteorological data from the Dessie station show that the year 2013 had above-average total rainfall. The total rainfall volume during the rainy season in 2013 (July–September) reaches 1041 mm, and the total annual volume reached 1550 mm. This was the third highest annual precipitation value since 1962 after 1998 and 2006 (see Fig. 3). For a detailed analysis of the correlation of the rainfall with the landslide activity, the precise dating of the reactivations is unfortunately missing.

**Fig. 3** Rainfall data from the Dessie graben from 2003–2013 compared with landslide events recorded by the testimony of local residents for the last 7 years (information from 2003–2006 is missing). Mean annual precipitation for this period is compared with the long-term average annual precipitation from 1962 to 2013 (which reached 1157 mm—horizontal black line). The small graph shows periods of high rainfall observed in July, August and September (average monthly precipitation 2003–2013)
